TYPE NO <b>CV7200 CV7300</b>	TYPE <b>Coffe Vending Machines</b>	T.I. NO <b>02</b>				
SERIAL NUMBERS AFFECTED <b>From and including S/N 30311536</b>	ISSUED BY <b>Documentation/N&amp;W Valbrembo</b>					
SUBJECT <b>GRIP step 2</b>		ISSUED FOR (X): <table border="1"> <tr> <td>Action</td> <td></td> </tr> <tr> <td>Information</td> <td><b>X</b></td> </tr> </table>	Action		Information	<b>X</b>
Action						
Information	<b>X</b>

## HEADLINE

- In all CV7200 and CV7300 machines from serial number 30311536 , the branch pipe, mixer cover fixation , CPU board and the overflow have been modified.

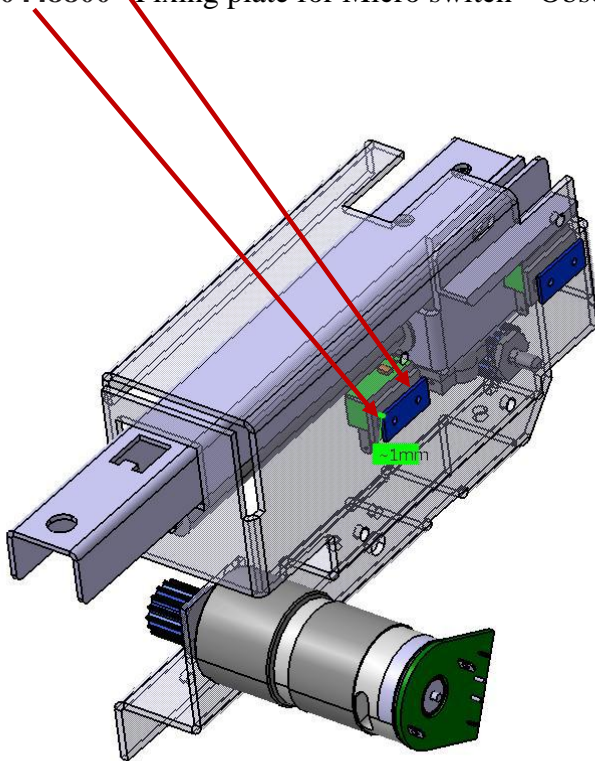
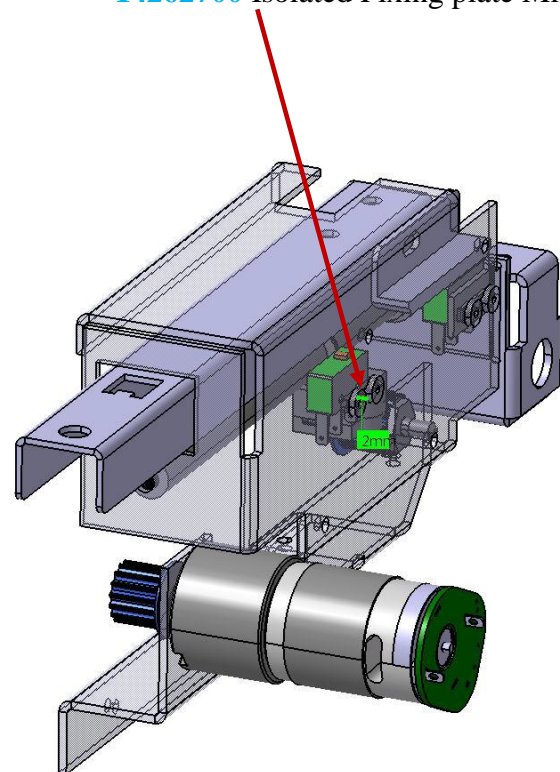
- Too little material thickness for the thread of the screw (1mm): the thread gets easily damaged and the fixing is not working anymore

- The metal plate is replaced by a insert in order to increase the thickness up to 2mm and a thread holder;

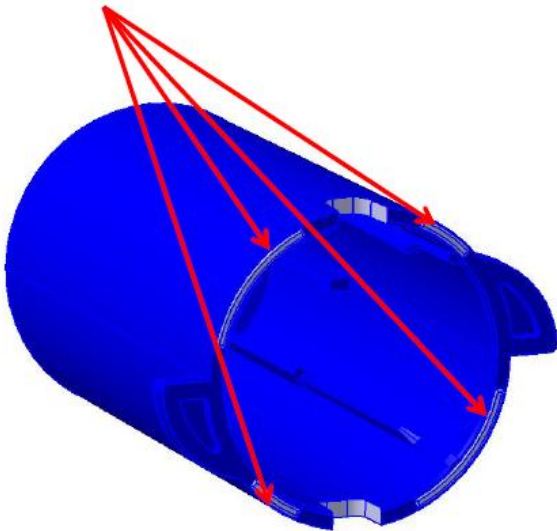
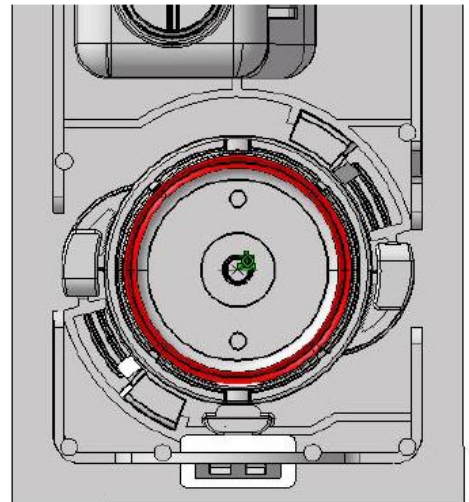
- TOO HIGH VIBRATION

- To prolong the lifetime of the V-ring and mixer motor and reduction of the sound pressure

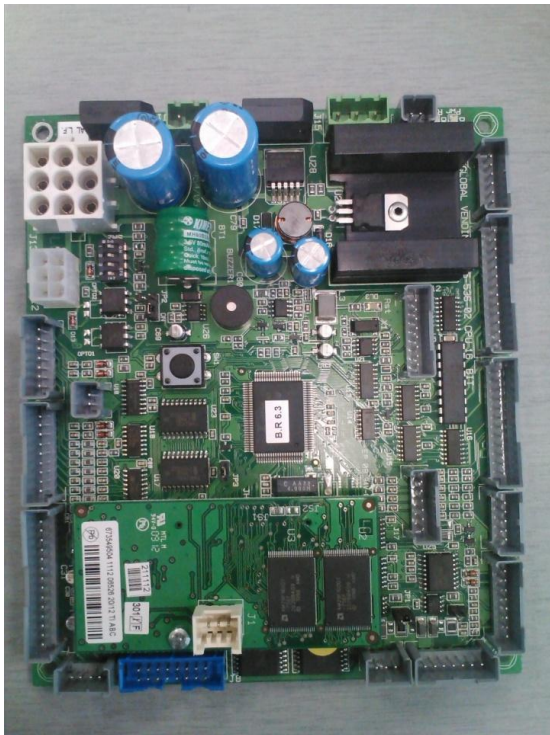
OLD

- In same case wrong initialing and not perfect communication between flash board and CPU board.

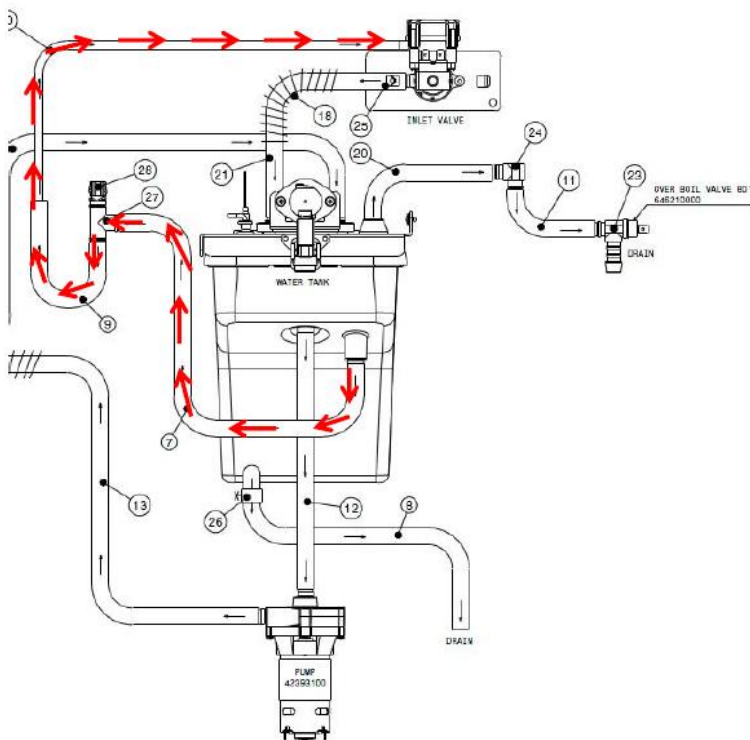
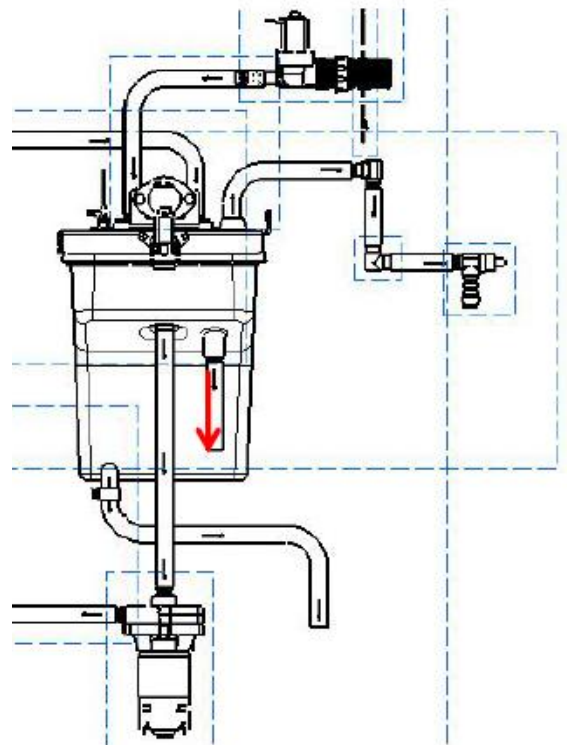
- Sometimes the overflow safety mechanism is activated even if there's not a flow issue. This causes mechanical blocking of the machine.

- The flow back to the inlet valve has been removed: the overflow is directed on the plastic bottom plate.
