SERVICE MEMO

Number: 2023-05
Dispenser(s): *Omni table top*
Title: Leaking ingredients containers

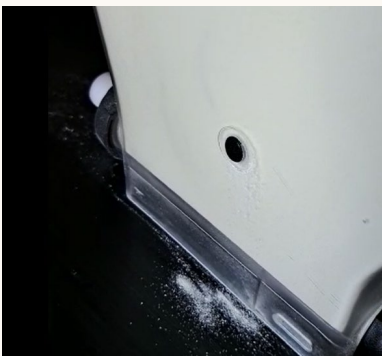
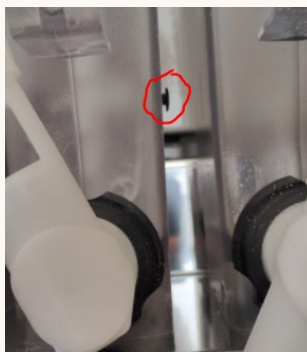
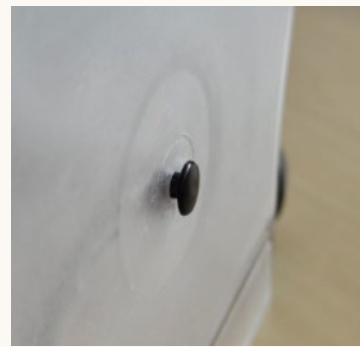
This leakage is caused by a sticking out locking pin of the worm wheel.
It will probably be pushed out if you forget to place the spout correctly after filling the canister.
Once the locking has been pushed out ingredient powder can enter the shaft of the worm gear, making it impossible to push the locking pin back to its original position.

If during a regular service or operating visit it is found that the locking pin sticks out:
Remove the locking pin, remove ingredient from the shaft of the worm wheel and remount the locking pin.

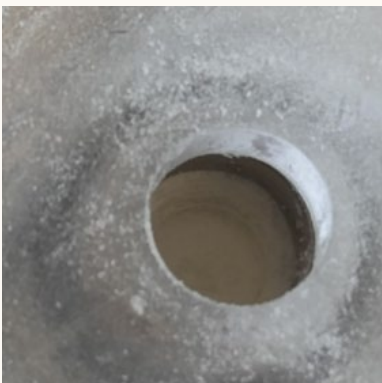
Shaft filled with ingredient:
