<b>T.I. no.: 2017 - 17</b> Updated: -	<b>Topic: Water tank and milk foam system</b>
--	---

<b>Date: 04.09.2017</b>	<b>Priority</b>	<b>Need for action</b>
Affected machines: SCClub	High	As soon as possible
From serial number: -	X Medium	X On next visit to the machine
As of date: -	Low	FYI only

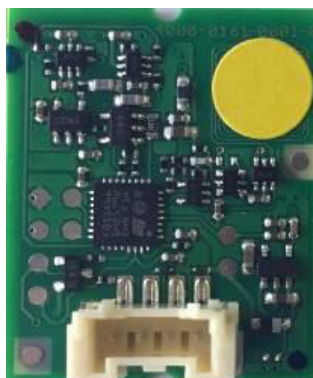
Yellow dot

- All level sensors shown here have the same hardware and software version and can be used without limitations.

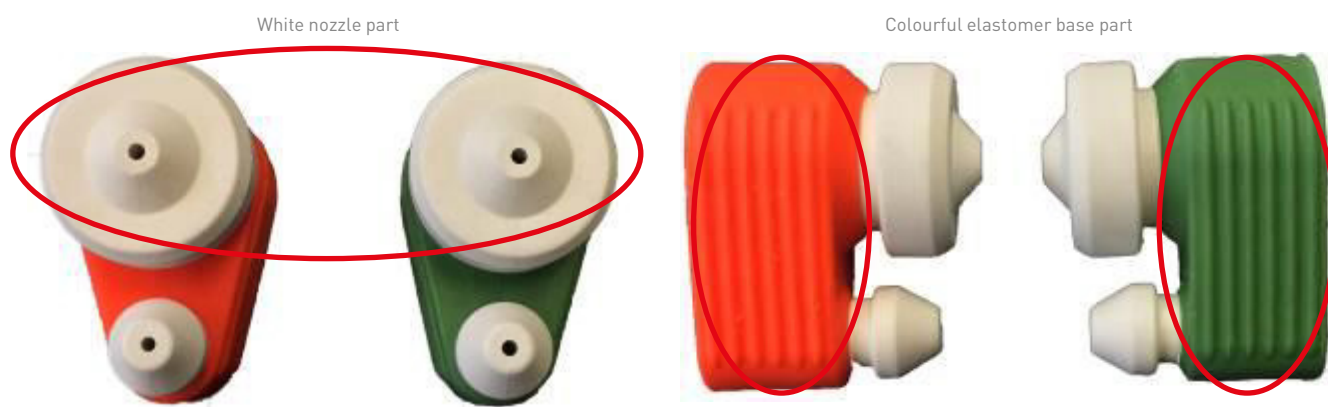
The reason for these messages is a supplier-side batch problem with defective milk nozzles which could potentially fail after a short operating time (typically within about 2 weeks).

Since the parts do not have a batch ID, visual detection of potentially defective parts is not possible. The colourful elastomer base part (green or orange) of the affected milk nozzles detaches from the white nozzle part and/or the bore holes in the nozzle part are not dimensionally accurate.

- Sort out personal stocks / spare part stocks
  - > Send parts back to the factory for credit (you can find the return address at the end of this info sheet)
- Order new milk nozzles
- Replace the milk nozzles in machines if needed, e.g. if the error is present - send the parts back to the factory for credit

- 1x - 33.4089.7100 green milk nozzle (suction chamber connection warm)
- 1x - 33.4089.7000 orange milk nozzle (suction chamber connection cold)

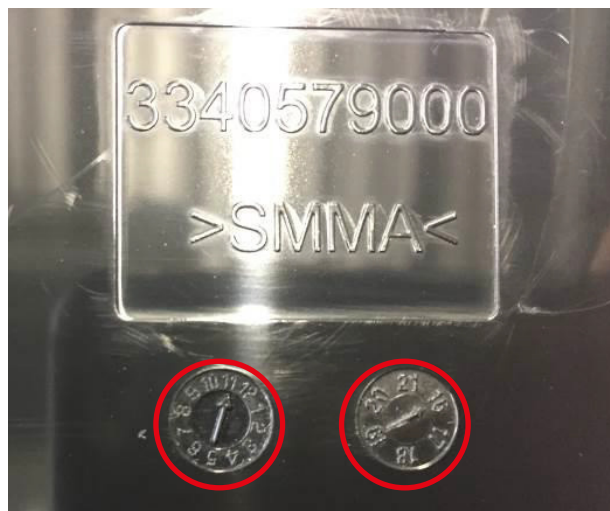
Very few messages from the field have reported that the base of the water tank leaks. The reason for this is a defective batch of water tanks in which the material was not completely hardened during the production process.

Potentially affected water tanks can be uniquely assigned to the date of manufacture. The date of manufacture can be found embossed on the base - all water tanks with date of manufacture 11/16 could be affected.

Month embossing / 11

Year embossing / 16

- Check personal stocks / spare part stocks, sort out if necessary
  - > Fill the water tank completely with water and set it on a dry, absorbent base (e.g. paper towel, kitchen towel). If moisture collects on the base after a short period of time, the water tank must be discarded.
- Order new water tanks
- Replace the water tank in the affected machines or send the customer a new water tank.

1x – 33.4057.9000 water tank
