T.I. no.: 2020 - 01 Updated: -	Topic: SC Club Software version 1.7.4
---	--

Date: 08.01.2020	Priority	Need for action
Affected machines: SC Club	High	As soon as possible
From serial number: -	X Medium	X On next visit to the machine
As of date: Immediately	Low	FYI only

PRODUCT INFORMATION ON THE SC CLUB – TI 2020-01 – SW V1.7.4

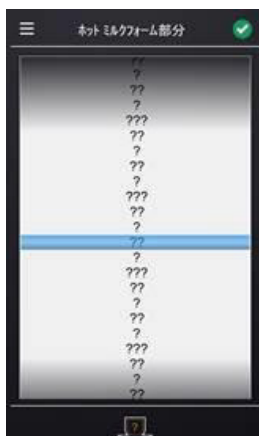
Faulty characters - Japanese and Russian

After the release of SW v 1.6.4, we received reports from many countries that the writing/characters were not correctly displayed in certain language settings and in individual menus. This has been corrected with version 1.7.4.

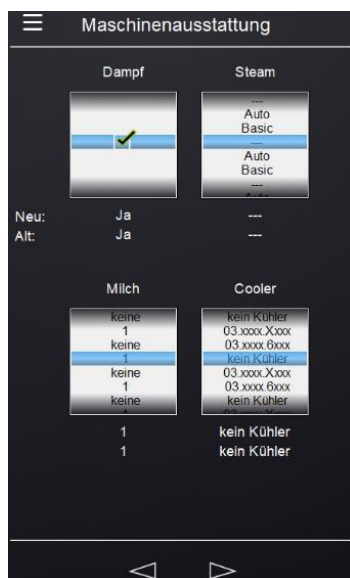
Menu navigation: **System > Machine configuration > Steam**

When "Steam" is activated, the "Steam"/"Milk"/"Cooler" options can be selected.

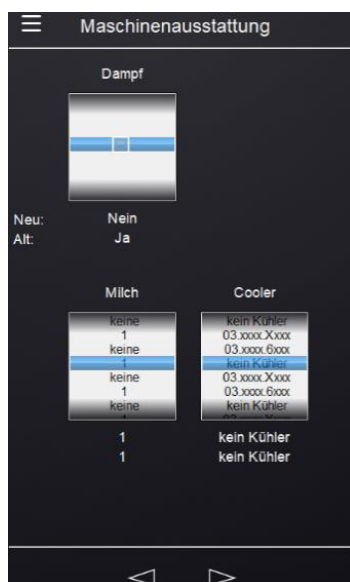
Previously

If "Steam" was deactivated, the "Steam" selection is hidden.

However, it was still possible to select the "Milk"/"Cooler" options as before.

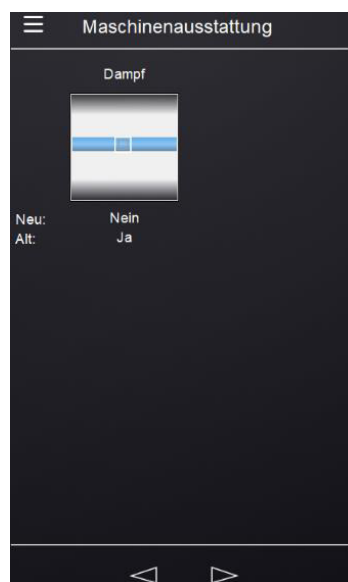
New

If "Steam" is deactivated, no other options can be selected for steam.

For machines in the field which do not have a steam boiler installed and are operated with a software version lower than 1.6.4, we recommend updating the software to version 1.6.4 or higher during your next planned service call.
