T.I. no.: 20 - 21 Updated: -	Topic: SC Club Software Version 1.8.3
---	--

Date: 03.12.2020	Priority	Need for action
Affected machines: SC Club	High	As soon as possible
From serial number: -	X Medium	X On next visit to the machine
As of date: immediately	Low	FYI

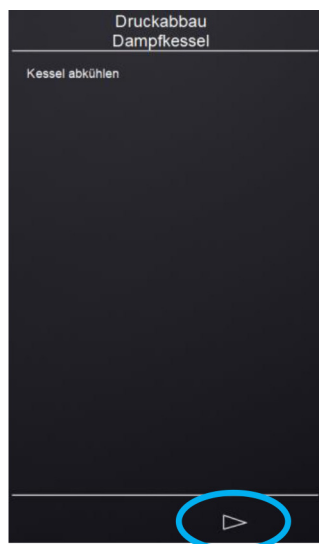
From the field, a case was reported in which after having entered the pressure reduction routine, the boiler heated up until the pressure relief valve triggered.

This could be reproduced by NOT starting "Cool boiler" by means of pressing the arrow key for a longer time after having entered the pressure reduction routine.

This error has been corrected and unwanted heating is avoided.
