<b>T.I. No.:</b> 2020 - 22 <b>Updated:</b> -	<b>Topic:</b> SC Club Software Version 1.9.4
---	--

<b>Date:</b> 03.12.2020	<b>Priority</b>	<b>Need for action</b>
<b>Affected machines:</b> SC Club	High	As soon as possible
<b>From serial number:</b> -	X Medium	X On next visit to the machine
<b>As of date:</b> immediately	Low	FYI

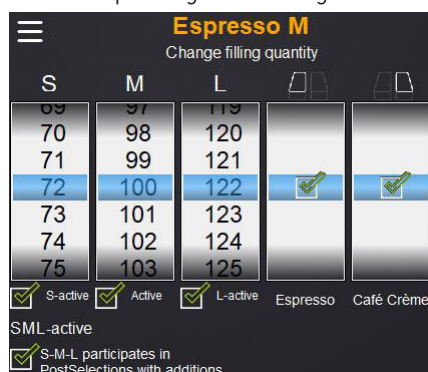
If PostSelection was activated on machines with 2 bean hoppers, so far it was not possible to select the type of coffee (grinder) before dispensing the beverage.

This has been changed with this software, and now the coffee type (grinder) not assigned in the basic recipe can be additionally activated under the beverage menu - fill quantities.

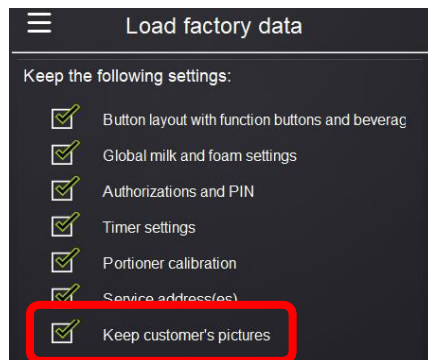
**Service > Machine data > Standards > Factory/Service-customer**

With the new software version, the possibility was implemented to keep or delete the customer pictures, which were transmitted via CoffeeConnect, under Factory/Service Customer.
