T.I. no.: 2015 - 05 Updated: -	Topic: Material fault in temperature sensor 063318
---	---

SUBSTITUTE DELIVERIES FOR TEMPERATURE SENSORS WITH MATERIAL FAULTS

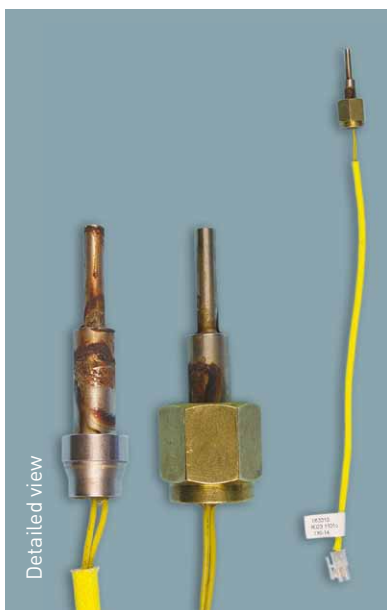
Due to a material fault on the part of the supplier, in the period CW40/2014 up to and including CW10/2015, temperature sensors were installed and supplied as a spare part that may corrode and fail (see left-hand diagram). This relates to article number 063318 temperature sensor NTC crimp plug.

Fault image of a corroded temperature sensor (063318)

- ▶ Check which machines are affected. Replace temperature sensor during the next service.
- ▶ Keep corroded temperature sensors removed for one year. As this is an insurance situation, these may be requested for return to Schaerer . Many thanks.

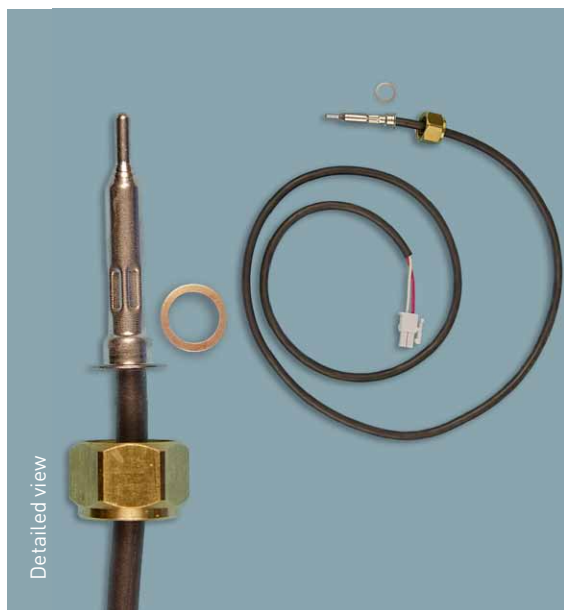
The revised version of the faulty temperature sensor will be tested straight away. During this transition period, temperature sensors from another supplier will be used (see centre diagram). These are tested and approved.

Temporary solution for temperature sensor with copper ring (068423)

When ordering 063318 during the transition period, the temporary solution will be shipped.

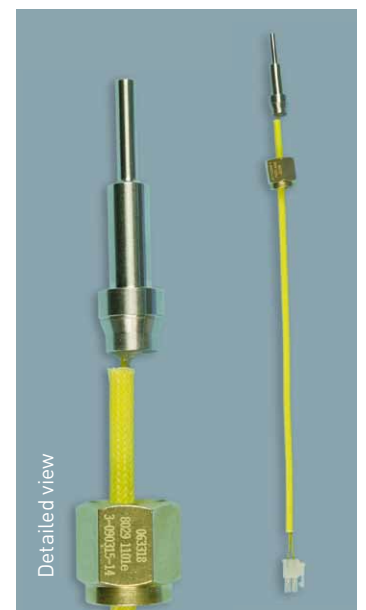
New temperature sensor with identification on the nut (063318)
