TYPE NO 7100 ES - FB - IN	TYPE Coffe Vending Machines	T.I. NO 03 - 2015				
SERIAL NUMBERS AFFECTED From and including S/N 41711049 (7100ES)	ISSUED BY Documentation/N&W Valbrembo					
SUBJECT STAINLESS STEEL STUDS FOR CUP STOP		ISSUED FOR (X): <table border="1"> <tr> <td>Action</td> <td><input type="checkbox"/></td> </tr> <tr> <td>Information</td> <td><input checked="" type="checkbox"/></td> </tr> </table>	Action	<input type="checkbox"/>	Information	<input checked="" type="checkbox"/>
Action	<input type="checkbox"/>					
Information	<input checked="" type="checkbox"/>

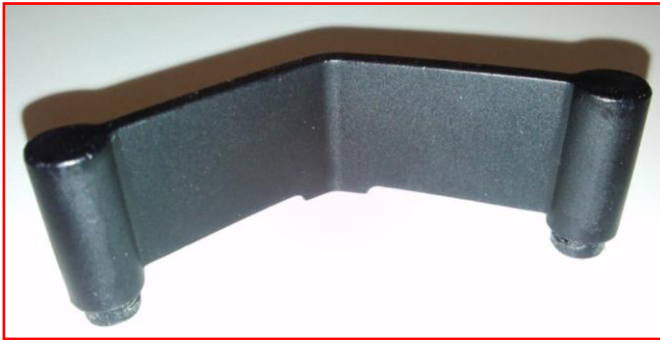
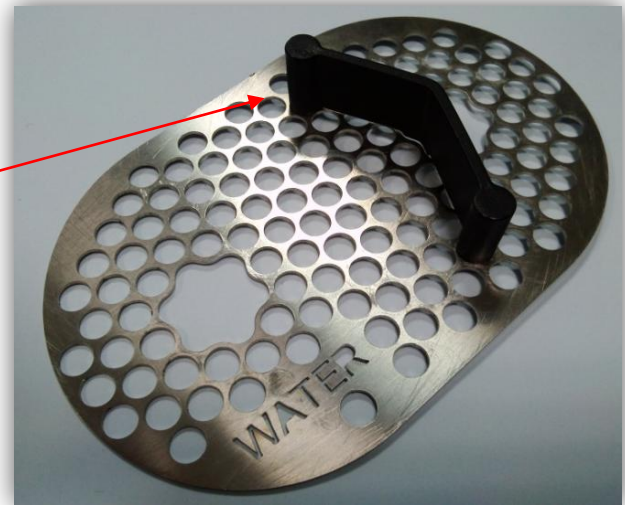
The existing CUP STOP solution does not guarantee a good fixing.

Below two pictures of the old CUP STOP

A new solution has been introduced.

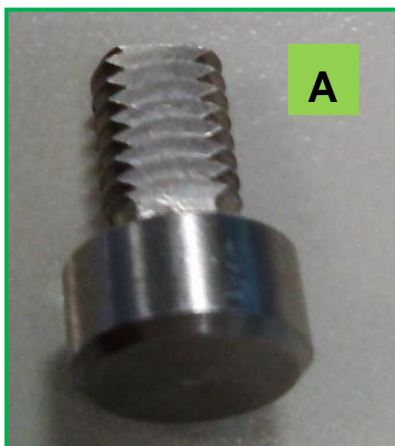
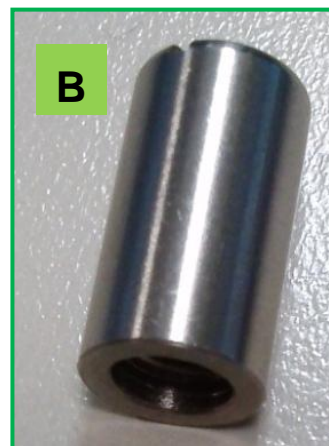
The new CUP STOP is made by :

- n. 3 "cup stop male thread pin (A) - Spare part code: **259068**
- n. 3 "cup stop female thread pin (B) - Spare part code: **259067**

The new cup stop solution can be installed in the machines prior to the above mentioned serial number.

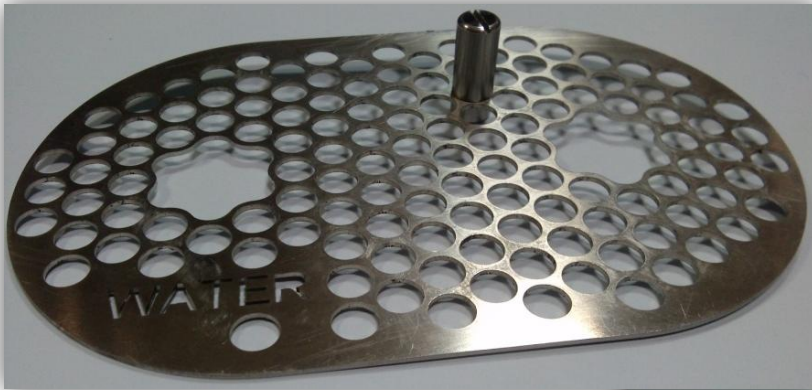
TOP view

Note: in the two pictures there's only one of the three steel studs used

The new cup stop solution guarantees a good fixing, thanks to the three fixed points.
