SERVICE MEMO

Dispenser(s): *Kometa*
Title: Check and/or change the way the release hose is mounted

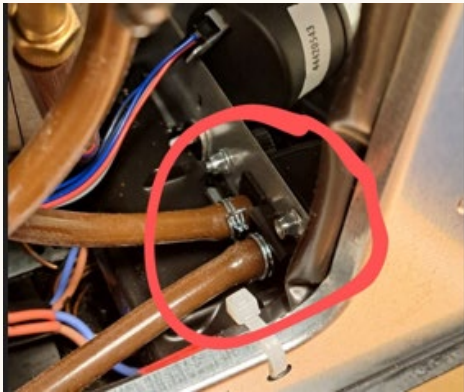
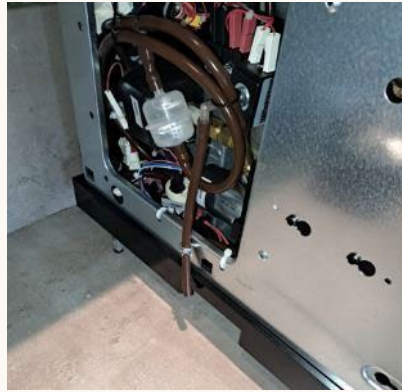
There have been reported issues with the coffee release hose.
In some cases it is reported that the hose is (coming) loose, which causes leakage under the machine.

Check with installation and or service visit the connection and modify if applicable.

Check connection hose, if not ok mount a correct clip
Check if the drain connector is staying into place, if not mount a screw to fixate.
