T.I. no.: 20 - 21 Updated: -	Topic: SC Club Software Version 1.8.3
---	--

Date: 03.12.2020	Priority	Need for action
Affected machines: SC Club	High	As soon as possible
From serial number: -	X Medium	X On next visit to the machine
As of date: immediately	Low	FYI

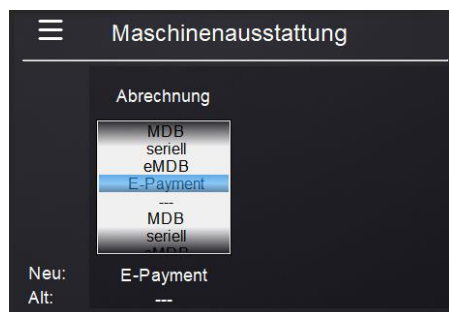
System > Maschinen configuration > Accounting > E-Payment

Activation under:

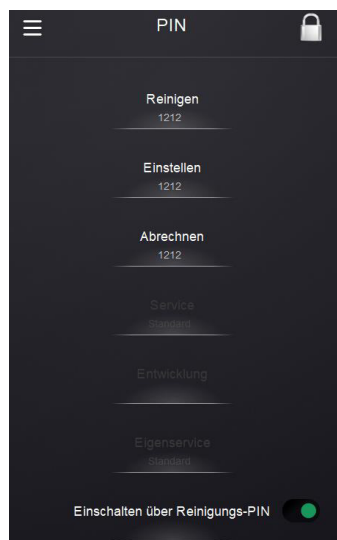
PIN > Switch-on via cleaning PIN

In the PIN menu there is now the possibility to lock the machine against unintentional switch-on (e.g. in conference rooms, lounges etc.).

For this purpose the menu item – Switch-on via cleaning PIN - has been integrated into the PIN menu. If the function is activated and at least one cleaning PIN is assigned, this PIN is requested upon switching on the machine. If the PIN is entered correctly, the machine starts as usual, if the PIN is entered incorrectly 3 times one after the other or no PIN is entered for longer than 10 seconds, the machine is switched off again.

With the known service PIN a locked machine can be put into operation at any time.

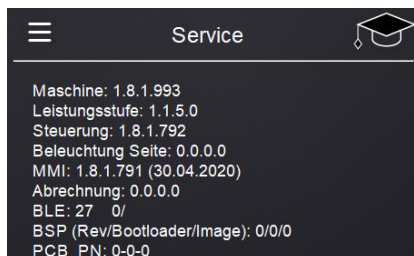
With the new software version, which now includes the BLE version 27, functionalities and optimizations which were already improved in 2019 have been implemented in the Bluetooth function "MyCoffeeApp".

After a software update, the new status can be seen in the info menu under **Info > Service > 2nd page with BLE: 27**.
