<b>T.I. No.:</b> 2020 - 22 <b>Updated:</b> -	<b>Topic:</b> SC Club Software Version 1.9.4
---	--

<b>Date:</b> 03.12.2020	<b>Priority</b>	<b>Need for action</b>
<b>Affected machines:</b> SC Club	High	As soon as possible
<b>From serial number:</b> -	X Medium	X On next visit to the machine
<b>As of date:</b> immediately	Low	FYI

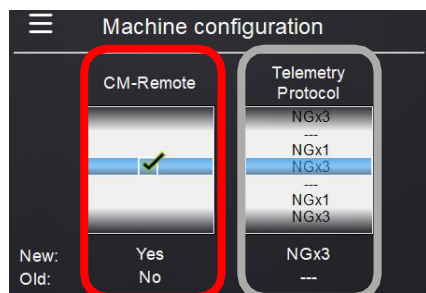
The general software activation is done under System > **Machine configuration** > **CM-Remote**

Important: Check whether the installed NGx3 telemetry module is activated. (marked grey)

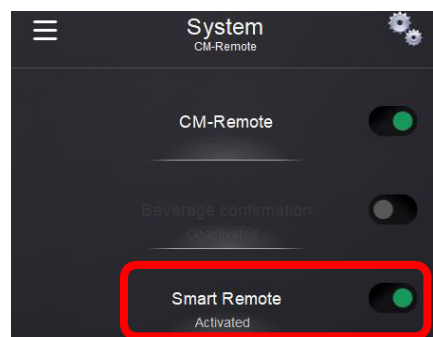
Under **System** > **CM-Remote Smart Remote** can then be activated or deactivated - even by the operator himself.

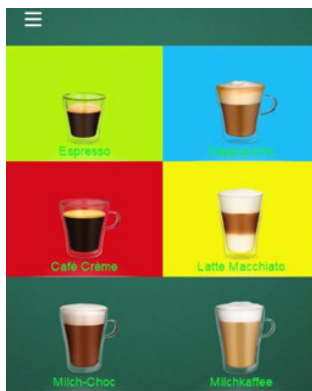
Before the background colour of the beverage buttons can be changed, the function must be activated under:

**System > Display and illumination > Beverage background.**
